INVESTIGATION

COLLAPSE

HOTEL VENDOME

WALTER J. HICKEY ASSOCIATES, INC.
ENGINEERS AND PLANNERS

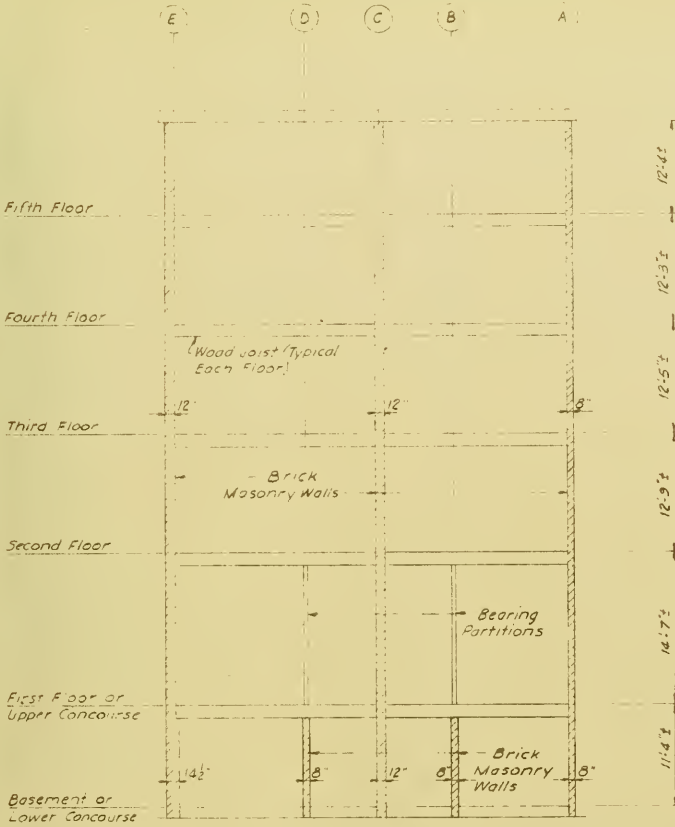
PLATE No. 2

SECTION A-A
